Creston Park Playground Bond Project

Technical Investigation Report

Portland Parks and Recreation

Mayer/Reed, Inc. | mayerreed.com

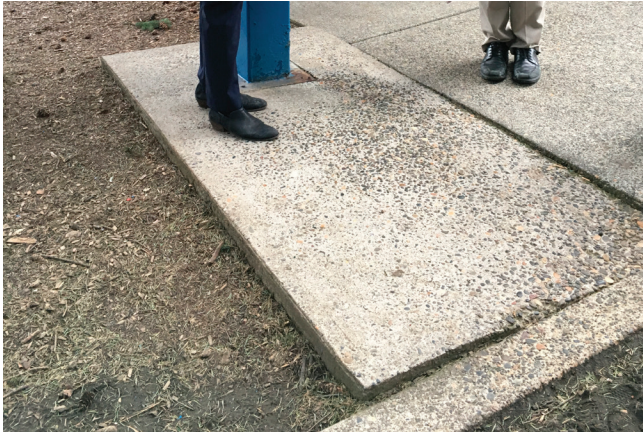
Paving at drinking fountain

There are two different types of paving on site; eight-foot width asphalt for the park paths and concrete paving at the wading pool and picnic area adjacent to the restroom. The park paths are in fair condition, though there are many locations where the cross slope exceeds ADA requirements. There are also several locations where adjacent trees are causing the paving to heave. There is currently no ADA code compliant route to the playground or the set of swings to the south. The paved plaza adjacent to the restroom is similarly out of ADA compliance. Large sections of the concrete have been lifted by roots, especially at the northwest corner.

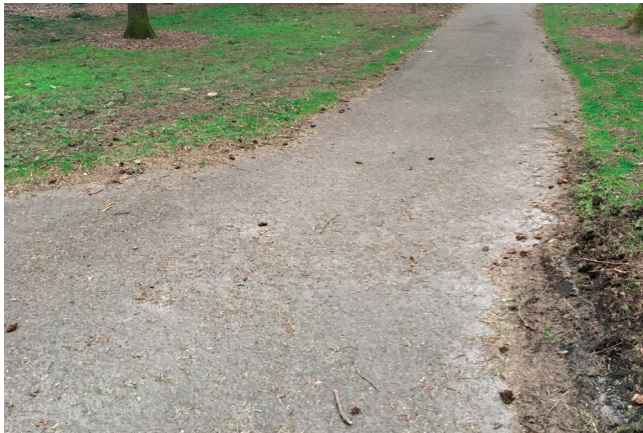
Asphalt path

- 4) Asphalt Path
 - a) Holen recommends no realignment of existing paved areas; locate the new path and other paving in the same location. Avoid excavation where possible. Recommends raising grades to meet ADA in lieu of lowering.

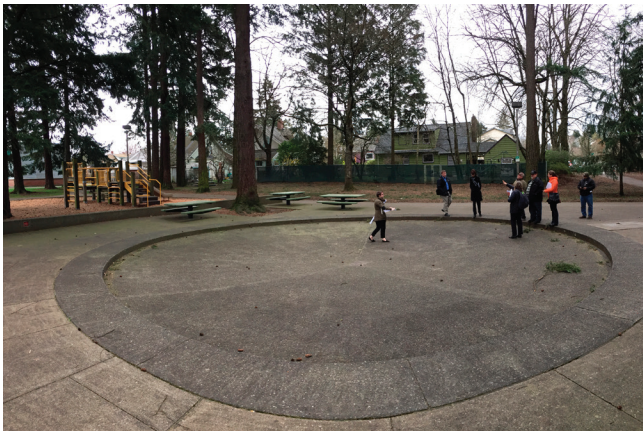
Former Wading pool

Wading Pool: The Oregon Department of Health (DOH) put regulations into place on December 31, 2009 for public wading pools. The regulations required water in public wading pools to be re-circulated, filtered and disinfected. The Creston Park wading pool would have had to be upgraded to meet the new DOH standards and to improve basic utility of the facilities. The wading pool receives heavy needle litter from the mature Douglas fir canopies above which had caused maintenance issues with the fountain mechanics. PP&R closed the Creston Park wading pool in 2009. Currently the former wading pool basin fills with stormwater and debris. The stormwater drains very slowly creating ponding which is a health and safety issue and a drowning hazard.

- Occasionally, there is a muddy spot below the tire swing where the kids have dug out the EWF. Otherwise there are no know drainage concern areas.
 - The depressed area in the middle of the non-functioning wading pool fills up with stormwater and tree debris in the winter (does not drain fast enough) – hazardous.

The wading pool is no longer used for its original intended purpose, and it is assumed that the drain to the sanitary sewer will remain if there are no modifications to the greater wading pool area. If the wading pool area is reconstructed into a pervious play area, it is assumed the drain will be disconnected to allow runoff to infiltrate into the subsoils.

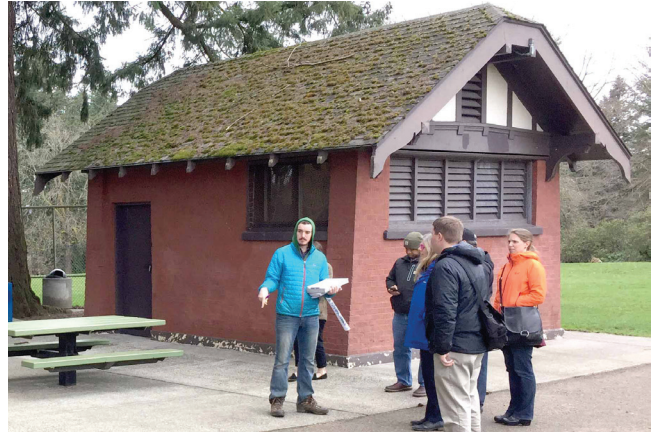
Restroom: A brick structure directly adjacent to the playground on the NE corner that houses two all-user restrooms and a small kitchen. One of the restrooms is ADA compliant. The building was redesigned in 2007 to incorporate the Creston Park kitchen to support the Summer Lunch program. Building upgrades are not included in the scope of work for the Creston Playground project.

Restroom

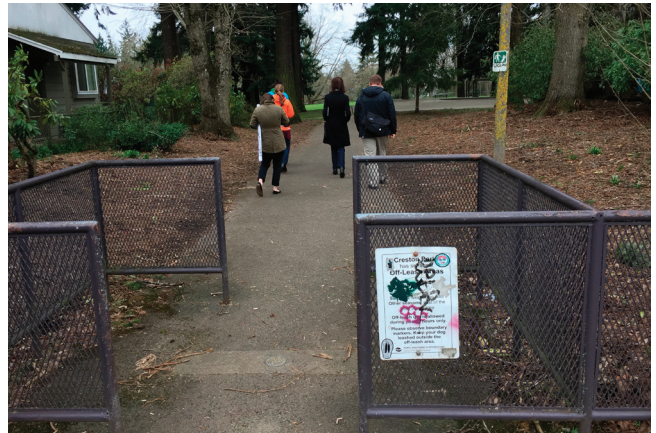
Fence: There is a four-foot-tall custom metal fence and gateway at the south entry to the park from Francis Street. It is currently painted brown. There is no gate associated with the fence, but there is evidence in the paving that a turnstile or other type of restrictive structure may have been in place in the past.

Entry gateway fencing and sign

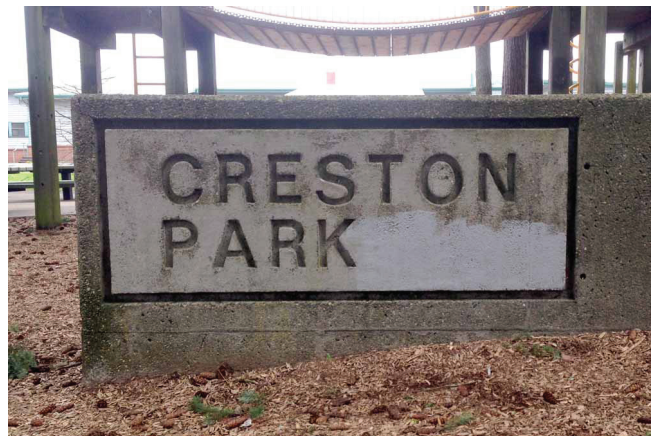
Wall: There is a freestanding concrete wall that separates the wading pool from a majority of the playground. There is a block-out halfway along the wall which might have, at one time, housed an electrical box, possibly used to control the wading pool fountain. Currently, it is boarded-up and has been spray painted red. At the north end's western face, the words "Creston Park" are formed into the concrete. At different locations along the wall there are signs of graffiti that have been painted over.

Freestanding wall and sign

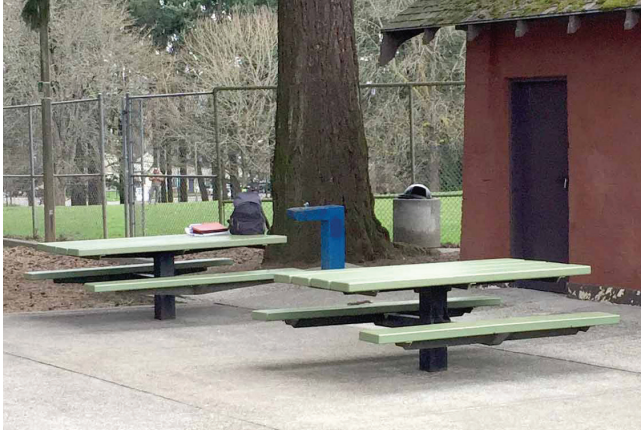
Picnic tables, drinking fountain and waste receptacle at restroom

Comments: The picnic tables are painted wood slats with a single steel embedded post. Two are located adjacent to the restroom, three are located adjacent to the wading pool and two are located on non-accessible concrete pads to the southeast of the play area. Some of the tables are showing rot in the boards. Though the tables are likely ADA compliant due to their central post, none are located on paving that is ADA compliant.

Comments: The drinking fountain is the "Blue Buffalo" style with one drinking station. It is functional though located on paving that is not ADA accessible due to root heave. It is assumed that the drinking fountain's water service originates in the restroom and that its internal drain is connected to sanitary line.

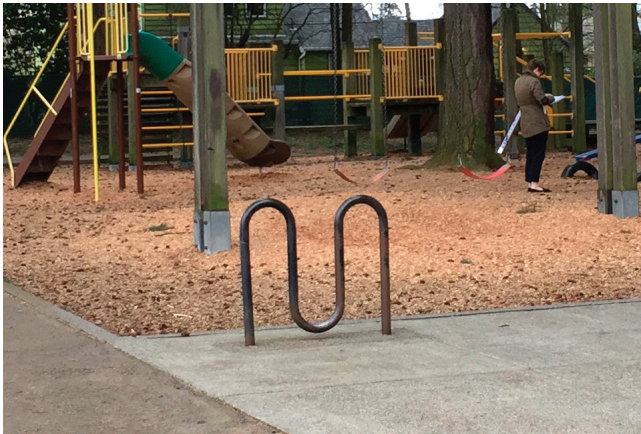
Bike rack

Comments: The ribbon style bike rack can accommodate four bikes. It has been painted black in the past, though the paint is mostly worn off. Bikes are more likely to tip over with ribbon style racks because they only have one contact point for the bike.

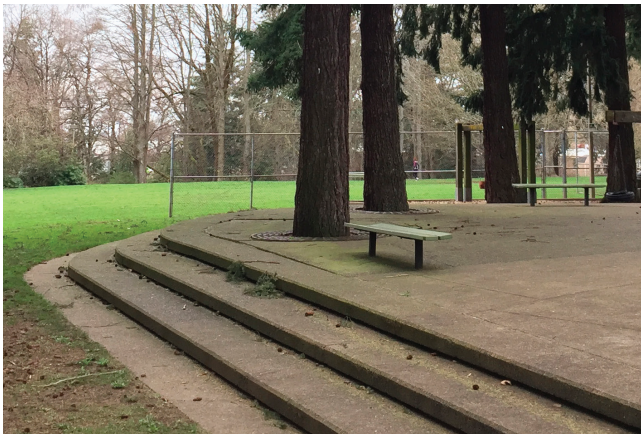
Benches and steps

Comments: The benches are painted wood slats with two embedded steel posts. Two backless benches are located at the northwest corner of the wading pool. The third, which is backed, is located near the steel swing set to the west. None of them have armrests and as such are not ADA compatible.

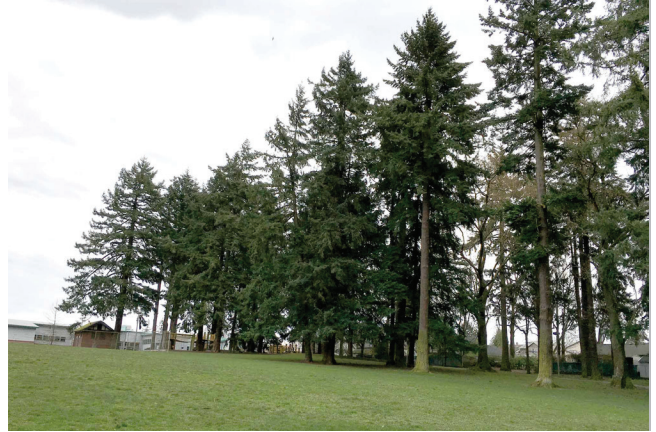
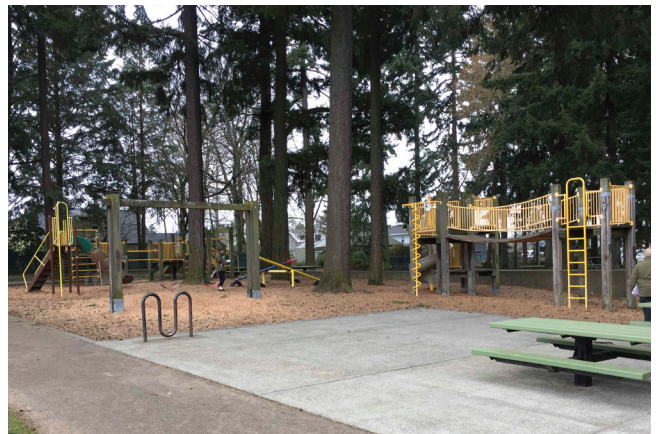
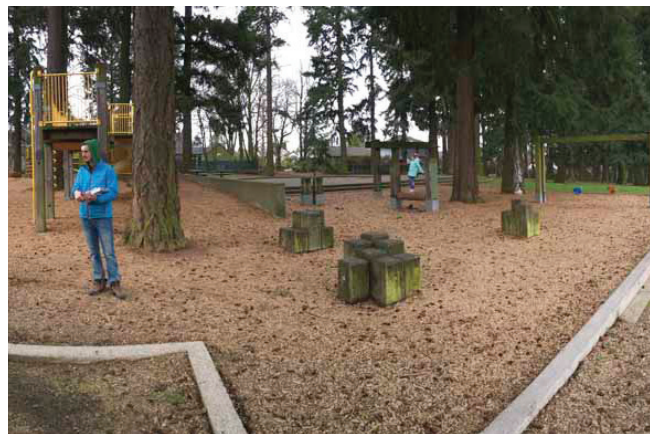
The equipment is mostly fabricated from large timbers, painted steel components and plastic slides. There are two pieces, a free-standing slide and the swings to the southwest, that do not have any wood components. PP&R and the design team will assess the life cycle costs and maintenance considerations to determine if wood components are the best long-term play solutions for this park playground. The heavily shaded environment provides a prime environment for algae and moss growth during the wet months, leading to safety concerns from slipping. In the long term, rot is also a concern.

The safety surfacing beneath the playground equipment is engineered wood fiber (EWF). If properly maintained, including correct installation in lifts and daily raking to keep a flat, flush surface, this product is an acceptable ADA surface. PP&R, like many other districts, is not staffed to be able to maintain the EWF to ADA standards. Additionally, the large trees within the play area are impacting the safety surfacing as their roots are most likely growing into and through the required depth for impact attenuation. Tree and play equipment placement are no longer compatible with the ASTM 6 foot fall zone (larger for swings). Finally EWF, though economical, is one of the most maintenance intensive of safety surfacing types requiring yearly material renewal to maintain impact depths and constant attention to fill holes, ruts and minimize material migration to other areas. This said, the positive aspects of the loose natural material for sensual experience, creative play and site appropriate design need to be considered.

Playground viewed from the northwest

Playground viewed from the northeast

Playground viewed from the restroom

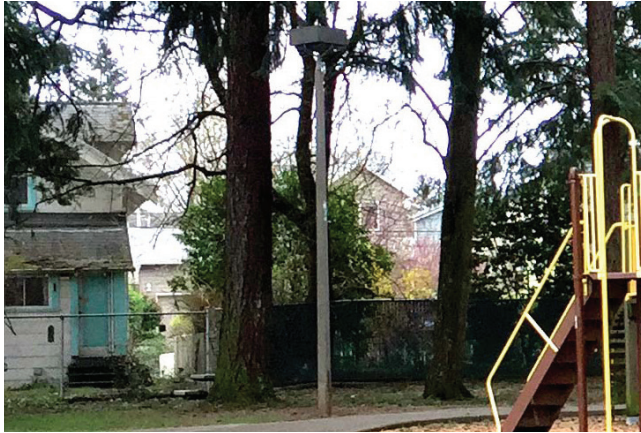
Light pole

There are three light poles within the project limit of work. These will remain and light fixtures will be replaced by PP&R staff.

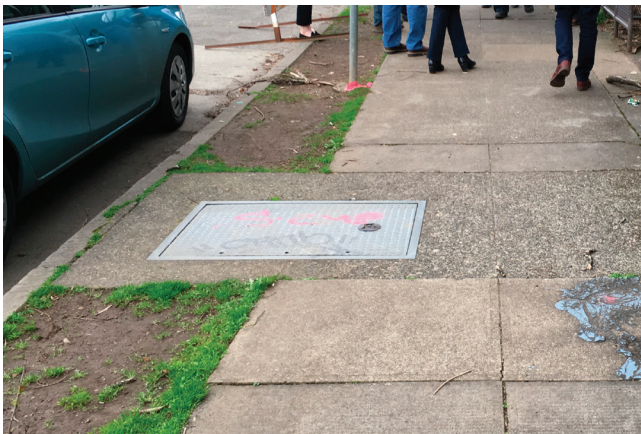
BFP device in the right of way

Domestic Backflow Prevention: based on information proved by John Lamar, the existing 3" BFP at the domestic water connection from Powell Blvd (north) does not currently met Portland Water Bureau (PWB) standards. PWB will likely consider this project as a trigger to require replacement for the domestic BFP device with a new reduced pressure BFP device which requires above-ground installation to allow for gravity drainage of intermittent water discharge to the ground surface during operation. This required heated enclosure to protect it from freezing and vandalism which requires a power source. This replacement is not currently part of the scope or budget for the project.

Water and Backflow Prevention: Based on information provided by John Lamar, the existing 3-inch BFPs at both water services do not currently meet Portland Water Bureau (PWB) standards. PWB will likely consider this project as a trigger to require replacement of the domestic BFP device for the SE Powell Ave. service with a new reduced pressure BFP device, and relocation of the irrigation BFP in SE Francis St. The existing irrigation BFP was noted as being in good condition, but is located in the meter vault within the right-of-way, and it needs to be relocated in a below-ground vault on the park property.

Reduced pressure BFPs require above-ground installation to allow for gravity drainage of intermittent water discharge to the ground surface during operation. The above ground installation requires a heated enclosure to protect from freezing and vandalism. Retrofitting a new reduced pressure BFP where a standard BFP was previously installed presents several challenges such as providing power for the heating element within the enclosure and finding a suitable location for the enclosure that is accessible but doesn't conflict with site access or use. The replacement and relocation of two BFPs and enclosures/vaults was not a part of the scope or budget for the project.

- Is currently located in the right of way (middle of the sidewalk). Needs to be relocated to PP&R property.
- Irrigation: Repair, installation of new by PP&R. Contractor to cap existing system.

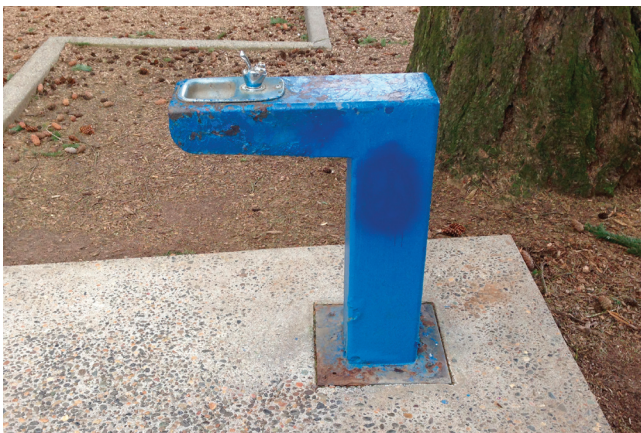
Drinking fountain

Drinking Fountain and Wash Station: The existing drinking fountain adjacent to the restroom building is to be replaced with a new ADA-compliant fountain as part of this project. Additionally, the project team is considering installing a wash station with an area drain to serve summer lunch program activities. It is assumed these fixtures can be served by the existing domestic water and sewer services that extend to the restroom building.

The replacement drinking fountain is assumed to have an integral trap. However, a vent and trap primer connection may be required for an area drain fixture to protect the water seal and prevent siphonage, back pressure, and exchange of sewer gasses. It is assumed the vent arm for this trap can be tied to the existing vent stack in the restroom building and the trap primer can be installed within the restroom building.

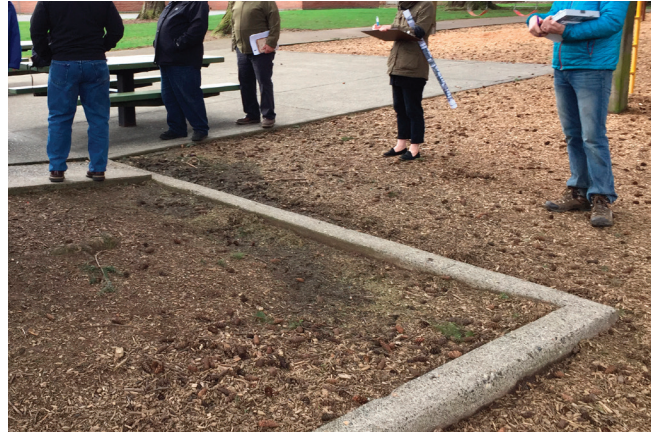
There is no known active stormwater drainage system. Stormwater sheets flows off paved areas and infiltrates on-site through the pervious surfaces including lawn and engineered wood fiber. Reference complete narrative by BHEGroup, the civil engineer on pages 23-25.

Playground surfacing and passive drainage concern area

Play Area Surface Replacement: The existing surfacing within the play area consists of a pervious organic material that is assumed to have equal or lower runoff potential than the adjacent lawn and landscape surfaces. BES staff have confirmed replacement of this surfacing with a new pervious surface will not trigger stormwater management requirements. It is assumed the native subgrade beneath the existing play area surfacing has sufficient infiltration rates to dispose of stormwater runoff from typical rainfall events. However, an underdrainage system may be needed if infiltration test results indicate poor infiltration rates.

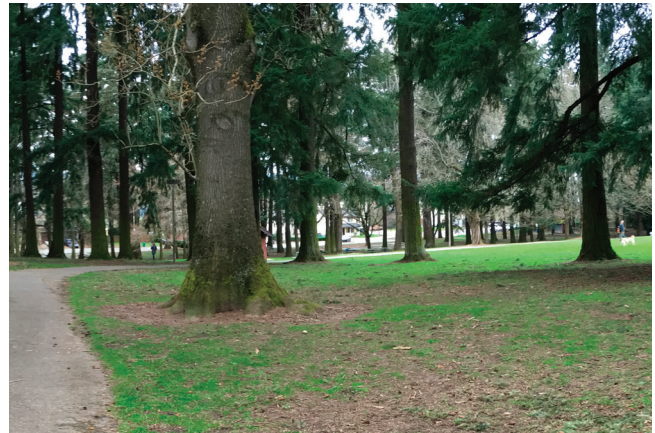
The vegetation consists primarily of lawn and mature trees. The existing playground coexists with a mature stand of Douglas firs. Along the south edge of the project more mature Douglas firs mix with various aged deciduous species such as pin oak. The south pedestrian access is lined with linden trees. The ground plane below this alley is mostly bare mulch with a background of large shrubs, primarily rhododendrons. Reference exhibits on pages 21-22 for the Project Arborist's tree inventory and site plan showing RPZs per Title 11 and co-dependent tree groupings.

Typical vegetation
