ENVIRONMENTAL OVERLAY ZONE MAP CORRECTION PROJECT

VOLUME 3, PART A2: Forest Park & Northwest District, Natural Resources Inventory and ESEE Decisions

(Resource Sites 21-41)

Discussion Draft
November 2019

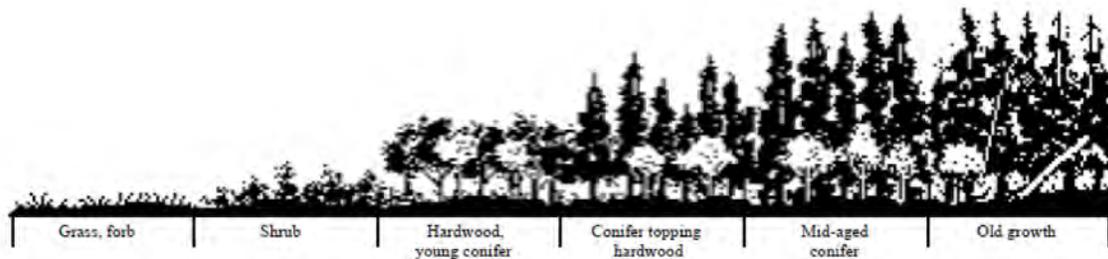
Figure 2. Stages of Northwest Hills forest succession

Houle (1982) describes the stages of the West Hills forest succession as: grass-forb, shrub, hardwood with young conifer, hardwood topped by conifer, mid-aged conifer and old growth vegetation types (see Figure 2 below). One additional vegetation type, mature hardwood, is also recognized but is not related to the Western Hemlock Zone successional sequence. This type, making up ten percent of the study area, typically occurs in moist to wet areas at lower elevations although occasionally it is found on dryer, upland sites. The distinguishing characteristics of the mature hardwood type are the dense stands of bigleaf maple and red alder and the near absence of conifers.

The grass-forb stage is comprised of low, herbaceous plants such as fireweed, bracken fern and Canadian thistle which initially colonize an area after removal of vegetation. This stage (two percent of the study area) lasts approximately two to five years and occurs along firelanes, power-line rights-of-way and in open fields along the crest of the hills and in lowland areas.

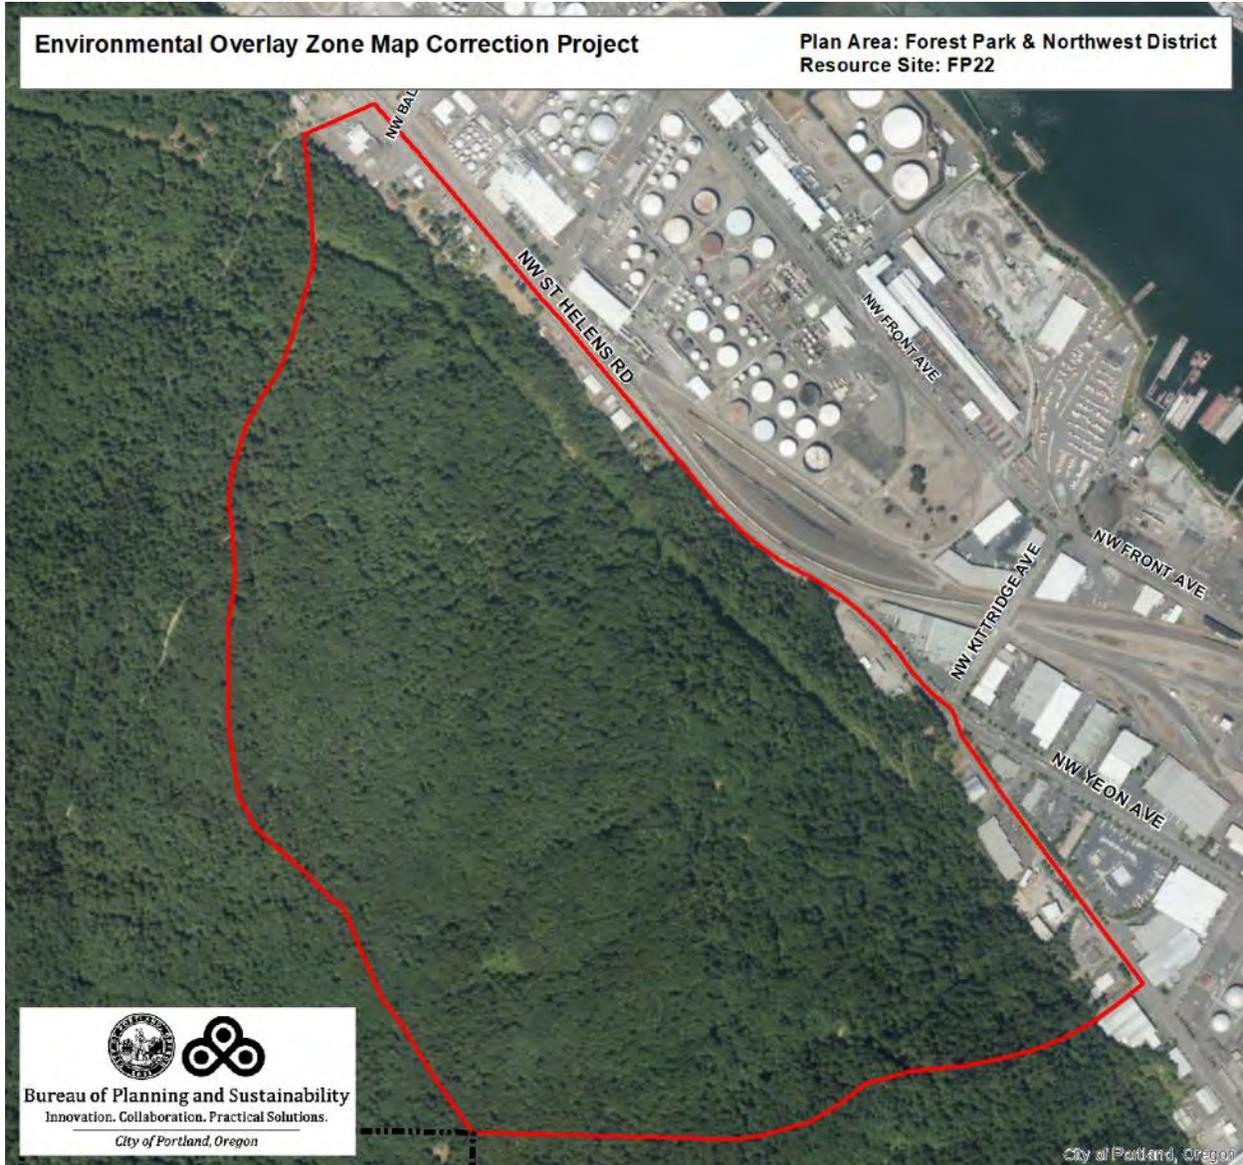
Resource Site No.: FP22 **Resource Site Name:** Firelane 1 – East Bluff
Previous Plan: Northwest Hills Natural Areas Protection Plan **Previous Resource Site No.:** 88

Table A: Quantity of Natural Resource Features in Resource Site		FP22
		Study Area
Stream (Miles)		0.4
Wetlands (acres)		0.8
Vegetated Areas >= 1/2 acre (acres)		359.5
	Forest (acres)	348.0
	Woodland (acres)	10.1
	Shrubland (acres)	0.0
	Herbaceous (acres)	1.4
Flood Area*		0.0
	Vegetated (acres)	0.0
	Non-vegetated (acres)	0.0
Steep Slopes (acres)**		356.4
Impervious Surface (acres)		20.8
* The flood area includes the FEMA 100-year flood plain plus the adjusted 1996 flood inundation area.		
**Slopes are derived from LiDAR. Steep slopes are area with a slope greater than 25%.

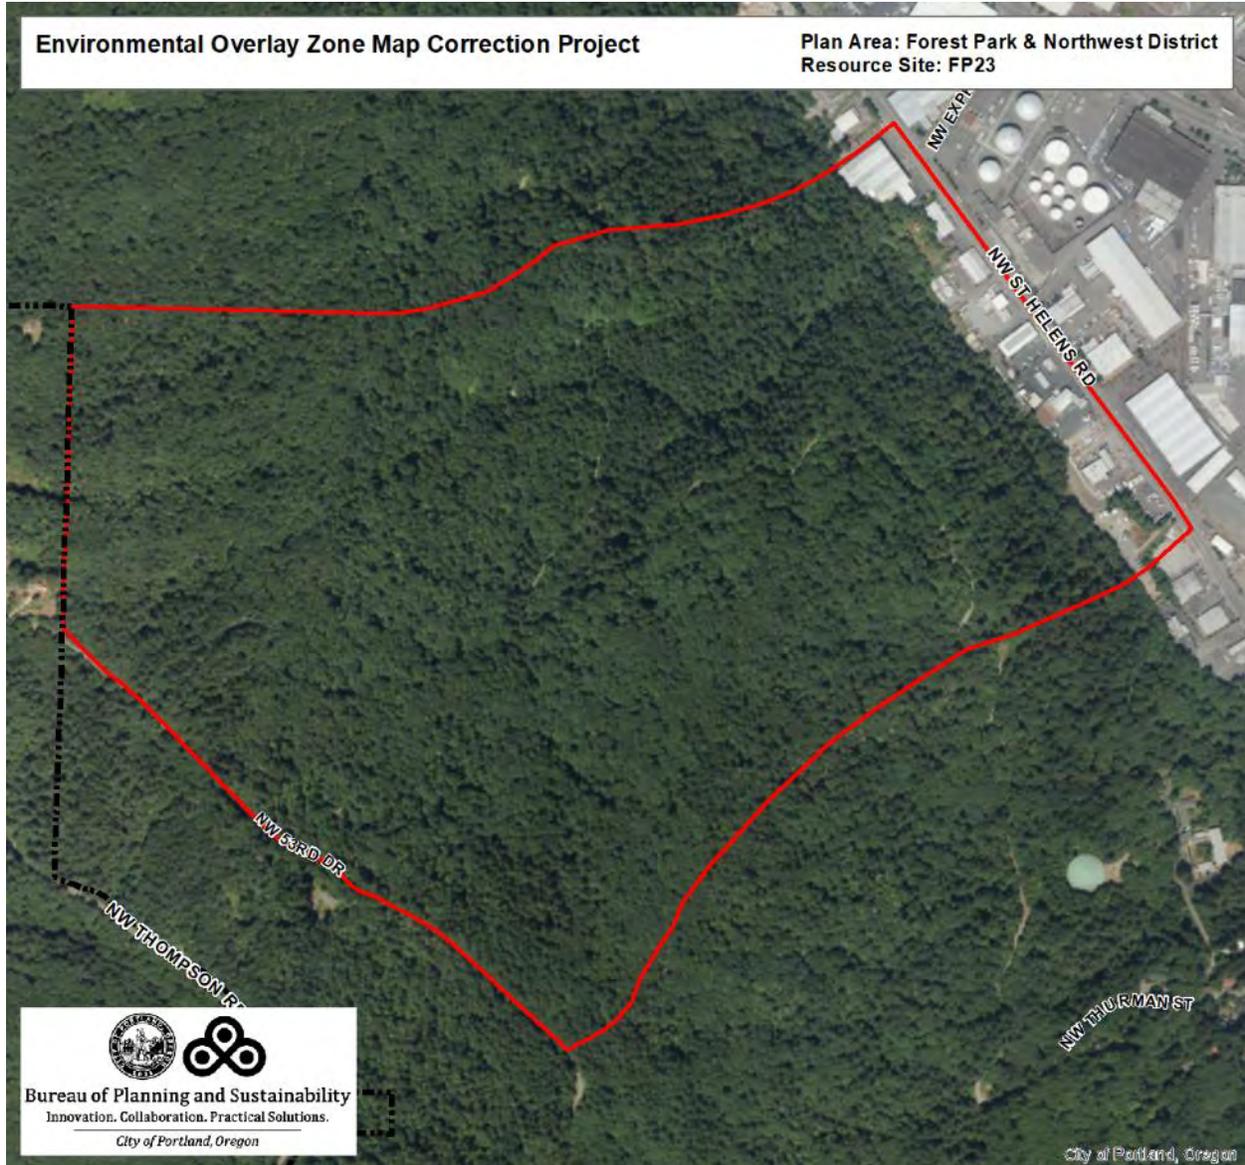
Resource Site No.: FP23 **Resource Site Name:** Express Creek

Table A: Quantity of Natural Resource Features in Resource Site		FP23
		Study Area
Stream (Miles)		0.2
Wetlands (acres)		0.0
Vegetated Areas >= 1/2 acre (acres)		269.4
	Forest (acres)	269.4
	Woodland (acres)	0.0
	Shrubland (acres)	0.0
	Herbaceous (acres)	0.0
Flood Area*		0.0
	Vegetated (acres)	0.0
	Non-vegetated (acres)	0.0
Steep Slopes (acres)**		265.7
Impervious Surface (acres)		33.6
* The flood area includes the FEMA 100-year flood plain plus the adjusted 1996 flood inundation area.		
**Slopes are derived from LiDAR. Steep slopes are area with a slope greater than 25%.

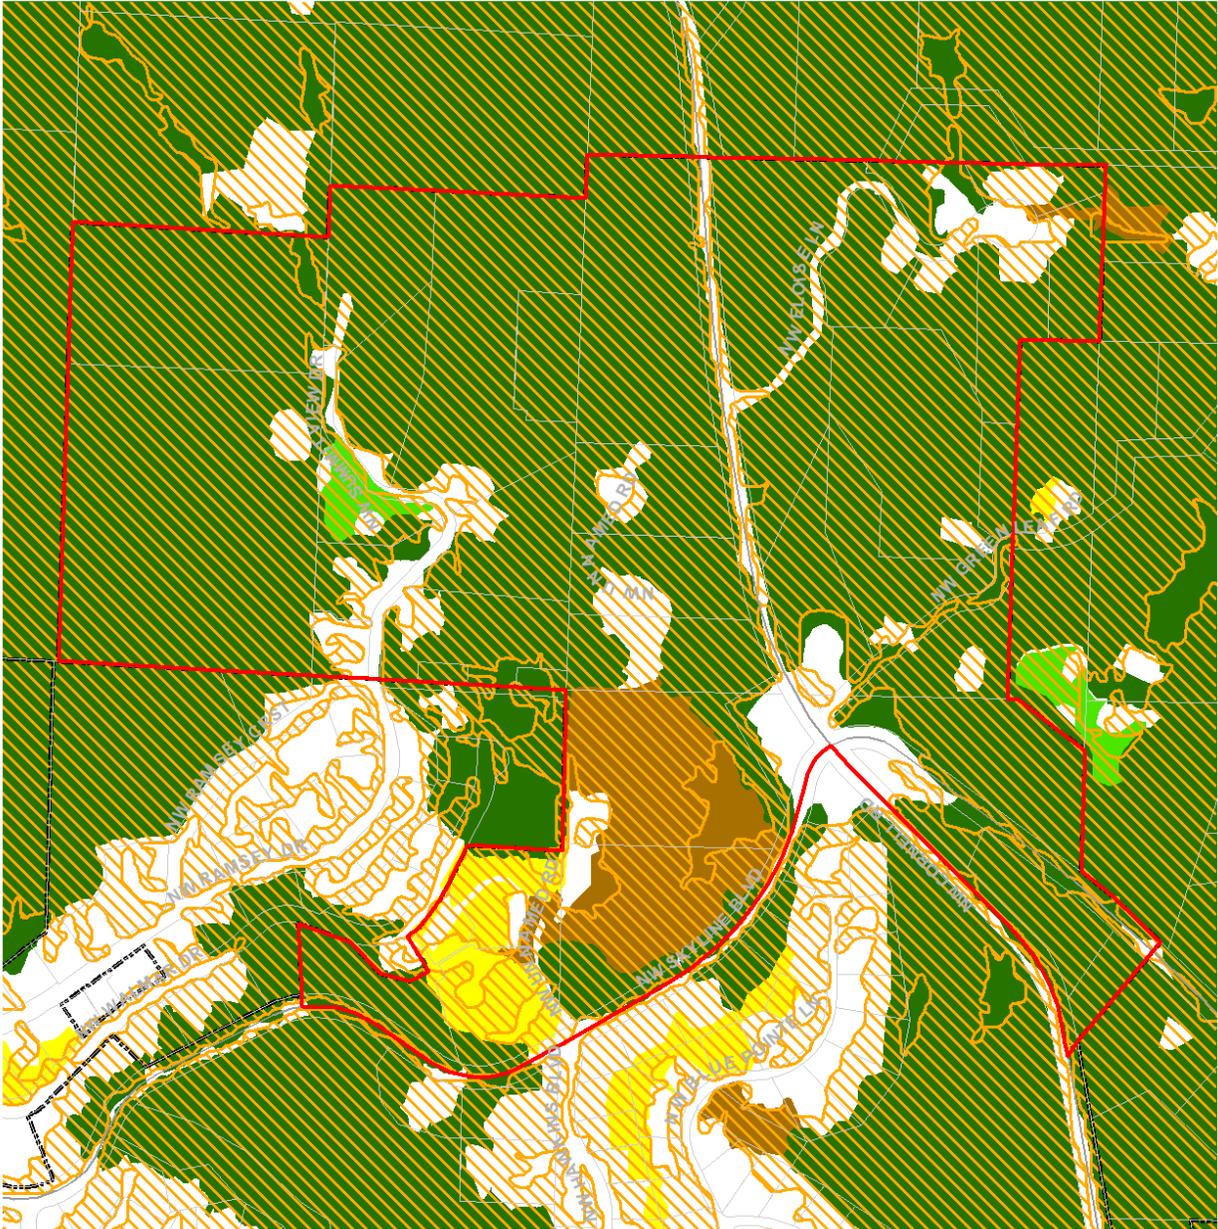
**Resource Site: FP26
Cornell Headwaters**

- Resource Sites
- Steep Slopes (>25%)
- Forest
- Woodland
- Shrubland
- Herbaceous
- Taxlots
- City of Portland

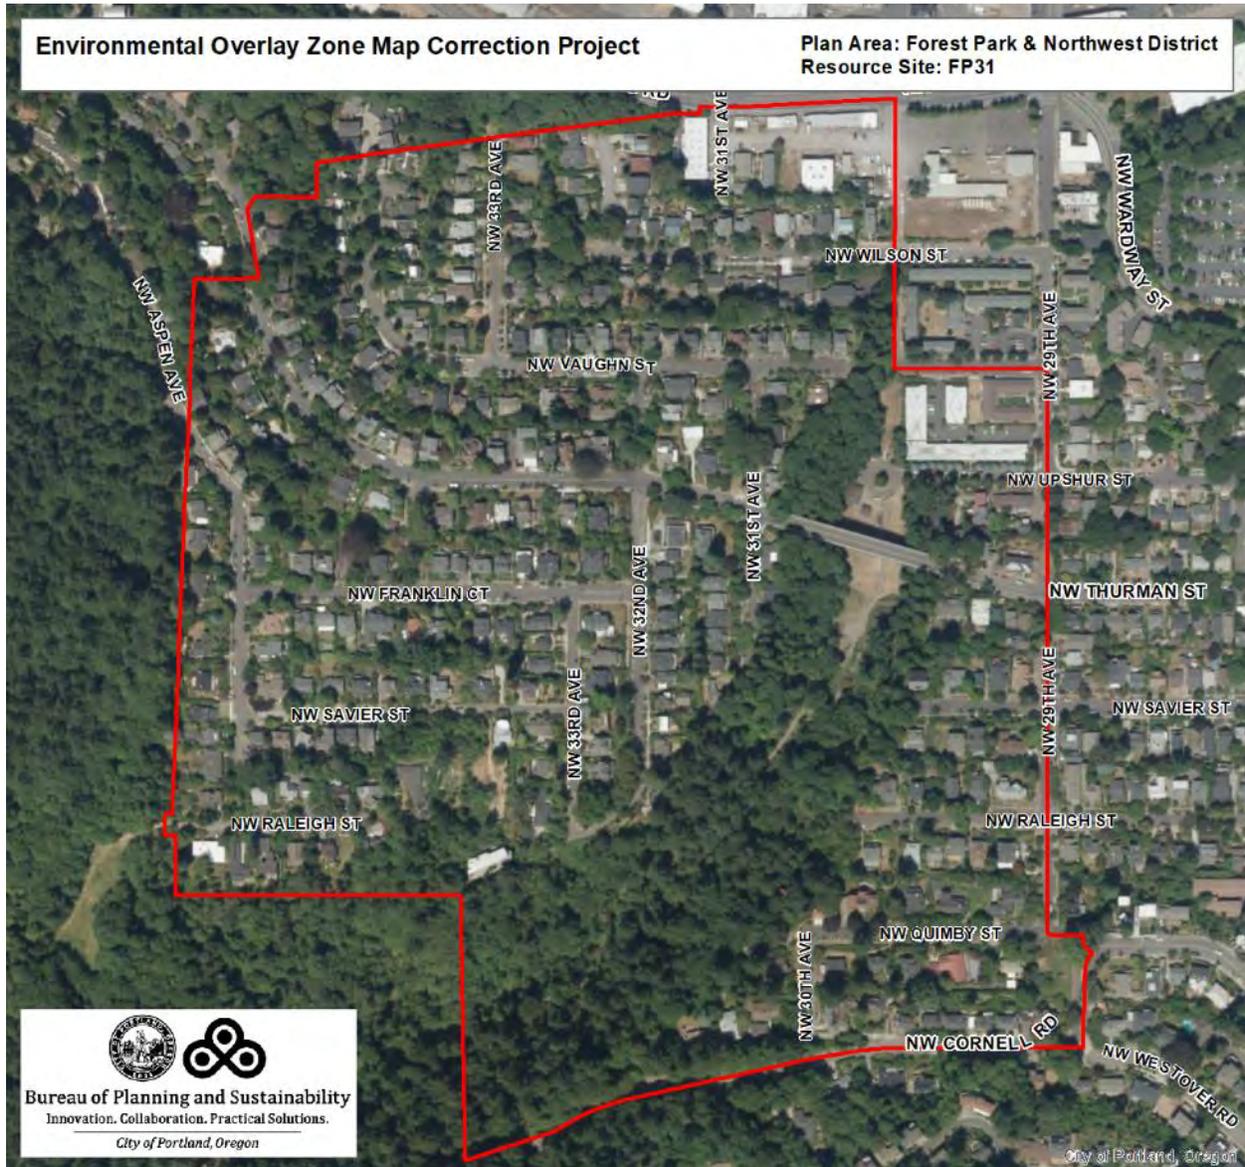
Resource Site No.: FP31 Resource Site Name: Lower Macleay

Table A: Quantity of Natural Resource Features in Resource Site		FP31
		Study Area
Stream (Miles)		2.4
Wetlands (acres)		0.0
Vegetated Areas >= 1/2 acre (acres)		24.4
	Forest (acres)	20.9
	Woodland (acres)	3.6
	Shrubland (acres)	0.0
	Herbaceous (acres)	0.0
Flood Area*		0.0
	Vegetated (acres)	0.0
	Non-vegetated (acres)	0.0
Steep Slopes (acres)**		55.0
Impervious Surface (acres)		38.6
* The flood area includes the FEMA 100-year flood plain plus the adjusted 1996 flood inundation area.		
**Slopes are derived from LiDAR. Steep slopes are area with a slope greater than 25%.
