Creston Park Playground Bond Project

Technical Investigation Report

Portland Parks and Recreation

Mayer/Reed, Inc. | mayerreed.com

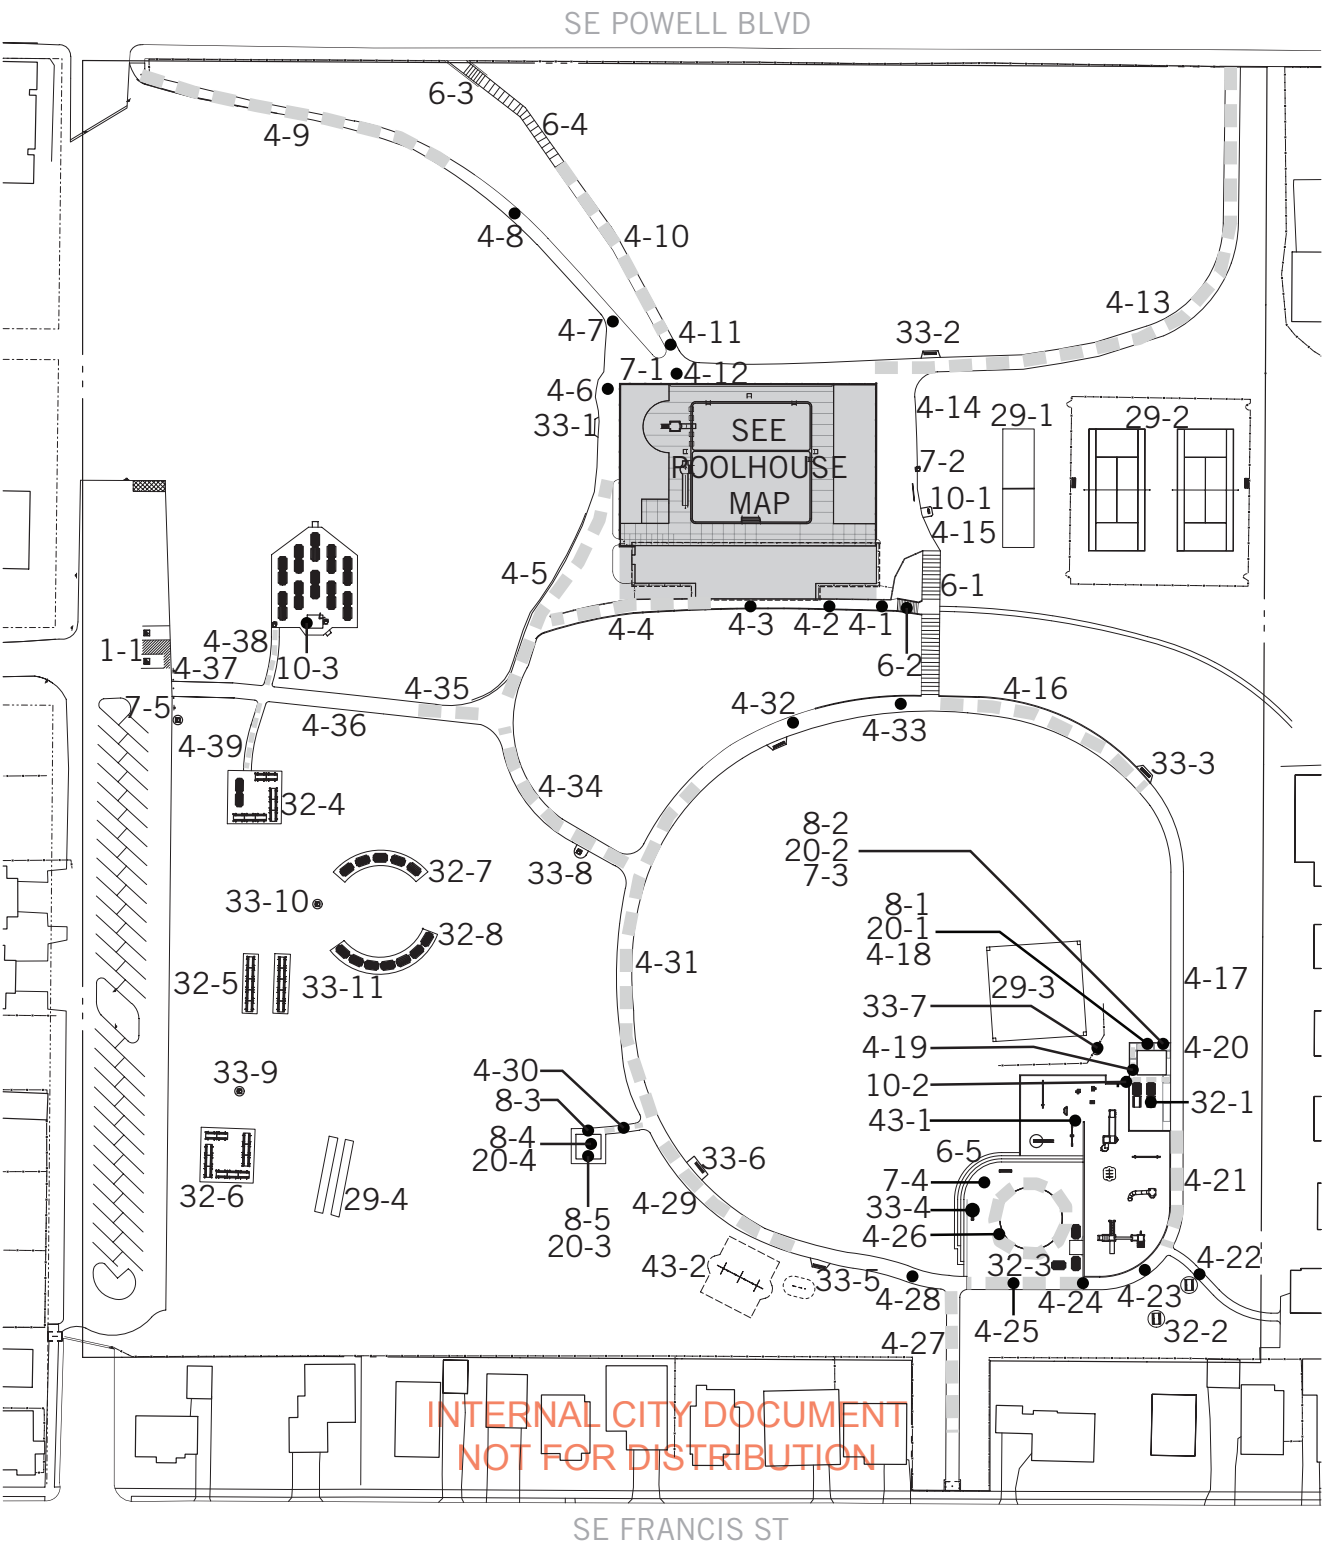
P&R-321: CRESTON PARK AND POOL
SE 44TH AVENUE AND POWELL BOULEVARD, PORTLAND OR

43-2 :: No accessible route to play equipment (swings). A 30" x 48" min clear space of 2% max is not provided at the swings.
