Creston Park Playground | Site Context | May 21, 2018 |

Mayer/Reed **Creston Park Playground** Existing Conditions | May 21, 2018 |

## CONCEPT#1: I SEE YOU!

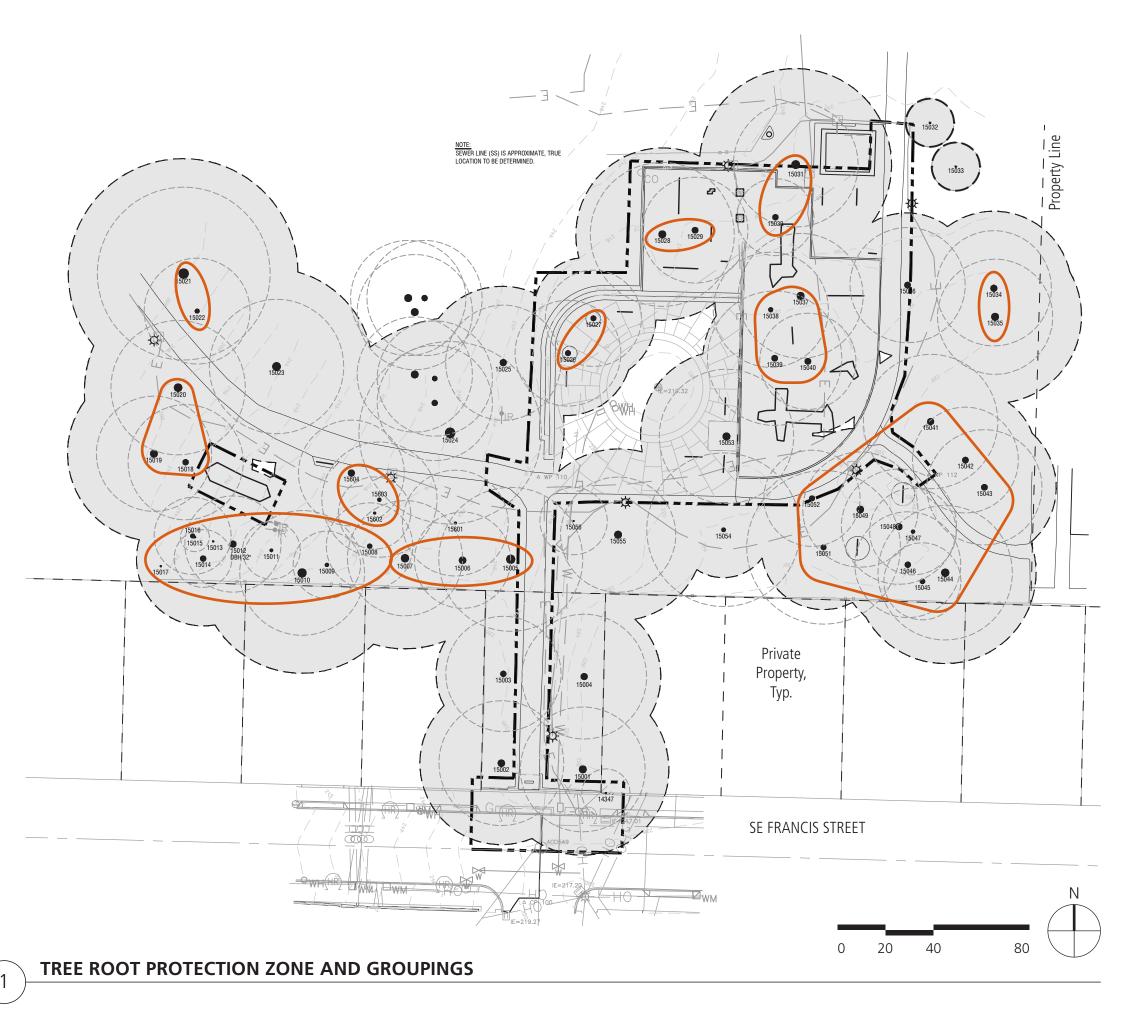
### TREE RPZ LEGEND Co-dependent Tree Groupings [ ] Root Protection Zone -- Limit of Work Existing Tree ⇔ Light Pole → Utility Pole Driveway Apron

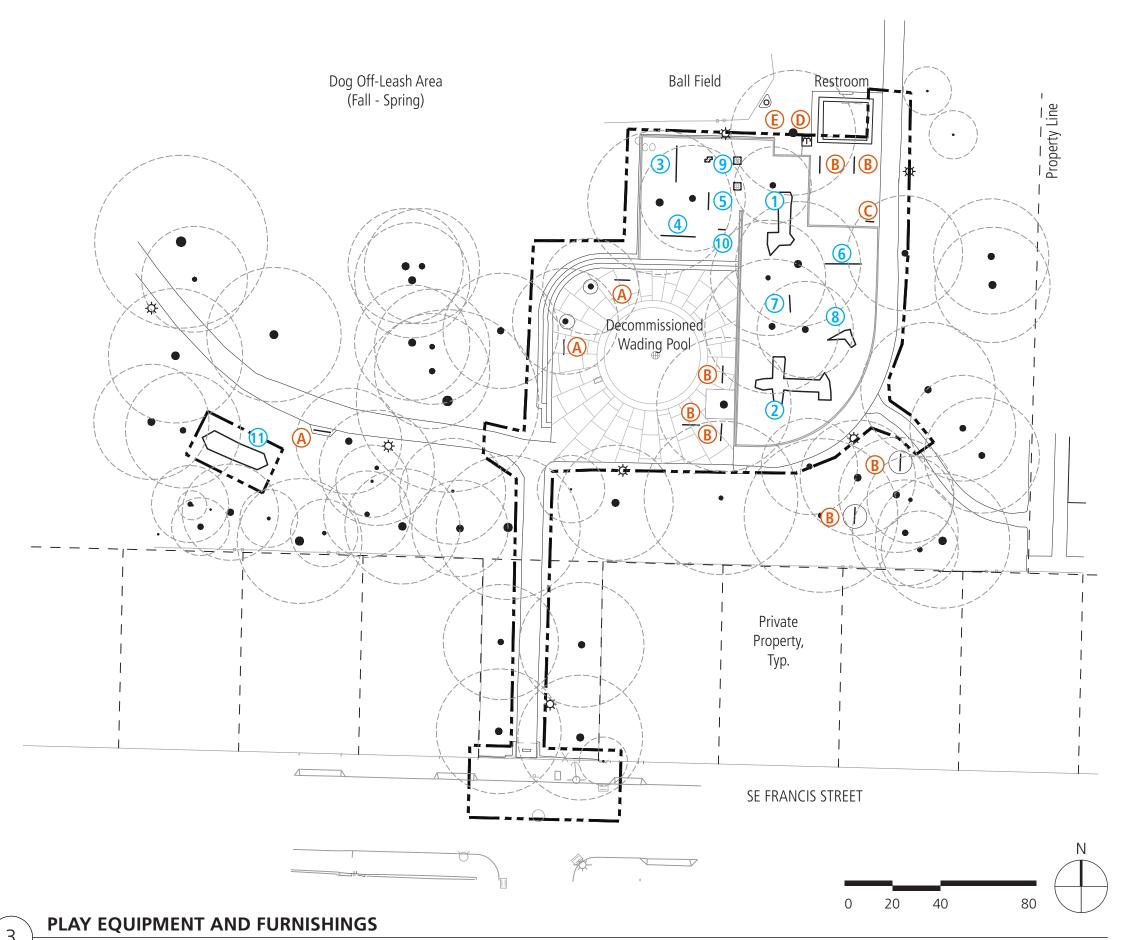
- ① Structure #1
- ② Structure #2
- 3 Toddler Swing Set (2 swings)
- Tire Swing
- S Roller
- 6 Swing Set (2 swings)
- 7 See Saw (2 planks)
- 8 Free-Standing Slide
- 9 Step-Ups (set of 3)
- See Saw (partially removed no plank)Swing Set (4 swings)

Type of Equipment	Manufacturer	Material			Types of Play									Comments / Conditions		
		Wood	Steel	Plastic	Swinging	Rocking	Brachiating	Sliding	Bouncing	Jumping	Climbing	Strengthening	Spinning	Running	Balancing

1. Structure #1	Timber Form	0	0	0				х		Х	Х	Х				Plastic slide; Rotting wood; Not compliant with fall zone
2. Structure #2	Timber Form	0	0	0			Х			Х	Х	х	Х		X	Multiple levels of difficulty of climbing; Plastic slide; Rotting wood;

3. Toddler Swing Set (2 swings)	Timber Form	0	0		Х											Not complant with fall zone Rotting wood
4. Tire Swing	Timber Form	0	0		Х										X	Circular Swinging; Non-compliant

5. Roller	Timber Form	0	0								X	X		Х	Х	Rotting wood; Non-compliant
6. Swing Set (2 swings)	Timber Form	0	0		Х							Х			X	Wearing rubber on seats; Not compliant with fall zone

7. See Saw (2 planks)	Unknown	0	0			X						х			X	Chipping paint; rotting wood
8. Free-Standing Slide	PlayCore Park Structure	0	0	0				Х			Χ	Х				Plastic slide; steep

9. Step-Ups (set of 3)	Timber Form	0								х	х	х			Х	Gouging; rot on tops
10. See Saw (partially removed)	Timber Form	0	0									Х			X	No wood plank present

11. Swing Set (4 swings)	Unknown		0		Х							х				(2) new seats; path not ADA accessible

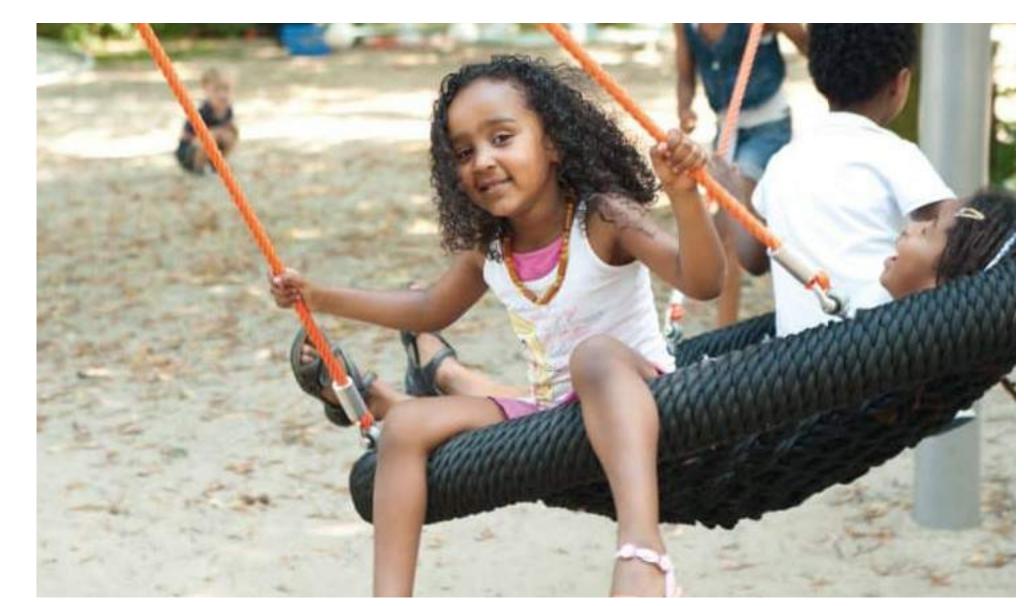
ROPE AROUND! - SECTION

1 Double Basket Swings
